## Case 238 : Narrative

Case Vehicle (A): 1999 Mercury	Vehicle (B): 2000 Chevrolet	Vehicle (C): 2000 Pontiac
Type: Sable GS, 4-door sedan	Type: Malibu LS, 4-door sedan	Type: Grand Prix, 4-door sedan
Driver: 33-year-old male	Driver: 63-year-old female	Driver: 34-year old female
CDC: 01-FDEW-2, 99-0000-0	CDC: 10-LBEW-4, 03-RBAN-3	CDC: 09-LPEW-1

CASE NO.: 238-01

CASE VEHICLE: 1999 Mercury

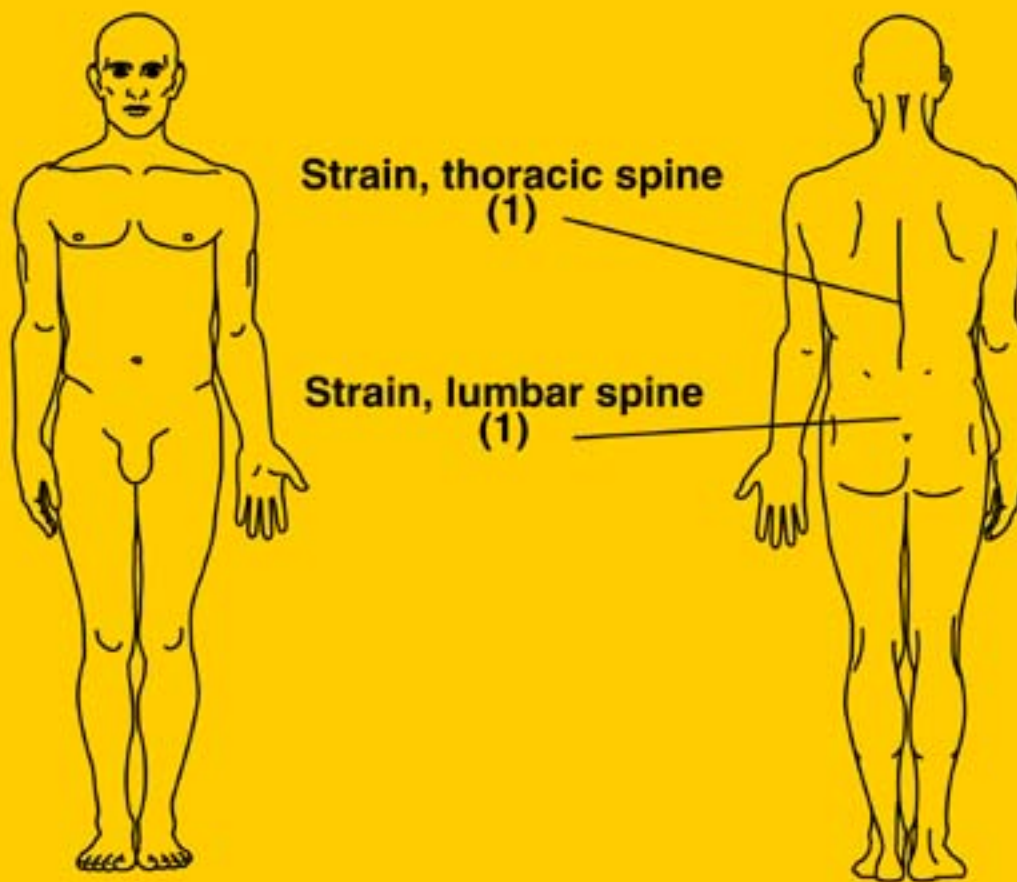
[51](#) During the frontal impact, he moved forward and to the right relative to the vehicle interior, into the airbag. He sustained thoracic and lumbar spine strain, due to impact forces during this multiple-impact crash. [52](#) [53](#) A scuff mark to the knee bolster indicates that the driver's knee probably contacted it, but no injury was noted.

Occupant: Driver	Age: 33 years	Gender: Male		
Restraints: 3-point belt <i>not</i> worn; airbag deployed	Stature: 178 cm (5 ft, 10 in)	Mass: 79 kg (175 lb)		
Injury Description	A.I.S.	Injury Source		
		Definite	Probable	Possible
—	—	—	—	—
Strain, thoracic spine	1	Impact forces	—	—
Strain, lumbar spine	1	Impact forces	—	—
Maximum A.I.S. Level	1	—	—	—
Injury Severity Score	2	—	—	—

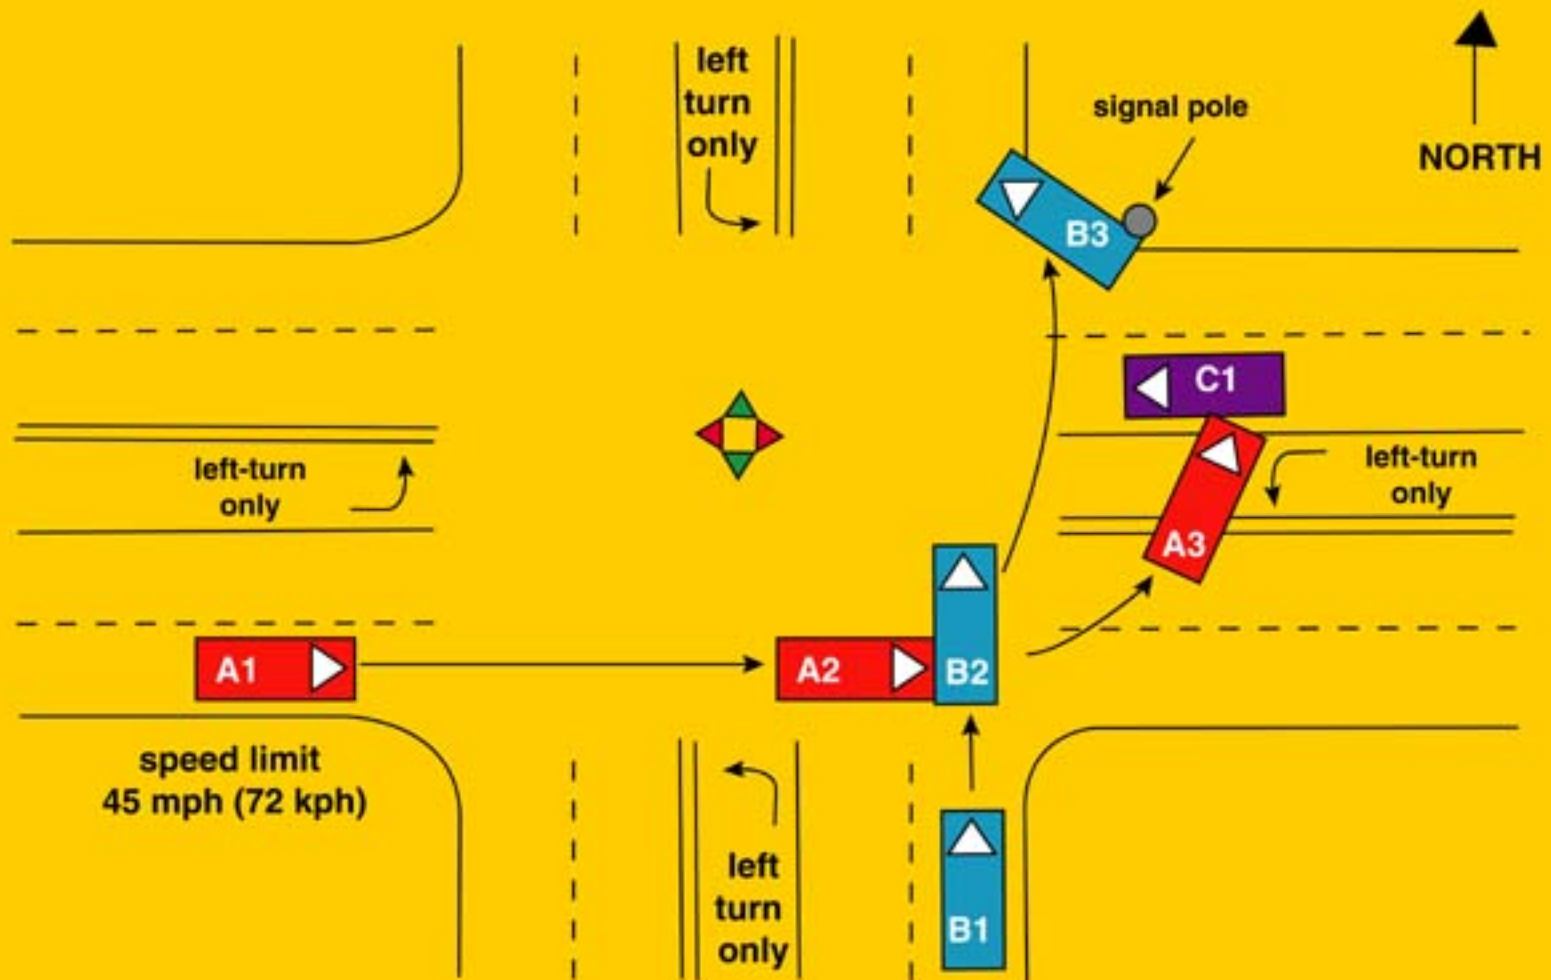
[1](#) [2](#) On a clear day, case vehicle (A) was traveling east at an unknown speed on a five-lane asphalt road in the right eastbound lane in an urban area. The road surface was dry, it was dark and lighted, and the speed limit was 45 mph (72 kph). Vehicle (B) was traveling north at an unknown speed in the right northbound lane of an intersecting five-lane roadway, and was approaching a four-leg intersection that is equipped with a traffic light. [3](#) As vehicle (B) entered the intersection, the driver of case vehicle (A) also entered the intersection and struck the left rear of vehicle (B) with its front end. After the impact, case vehicle (A) continued to travel east, rotated counterclockwise, and crossed the centerline. Vehicle (C) was stopped facing west in the left westbound lane. Case vehicle (A) then entered the left westbound lane, where it struck the left side of vehicle (C) with its front end. After the impact, vehicle (B) rotated counterclockwise and exited the northeast corner of the intersection and struck a utility pole with its right rear. Case vehicle (A) was towed from the scene and the driver was transported to a local hospital. The driver of case vehicle (A) had a blood alcohol content of .29 percent at the hospital.

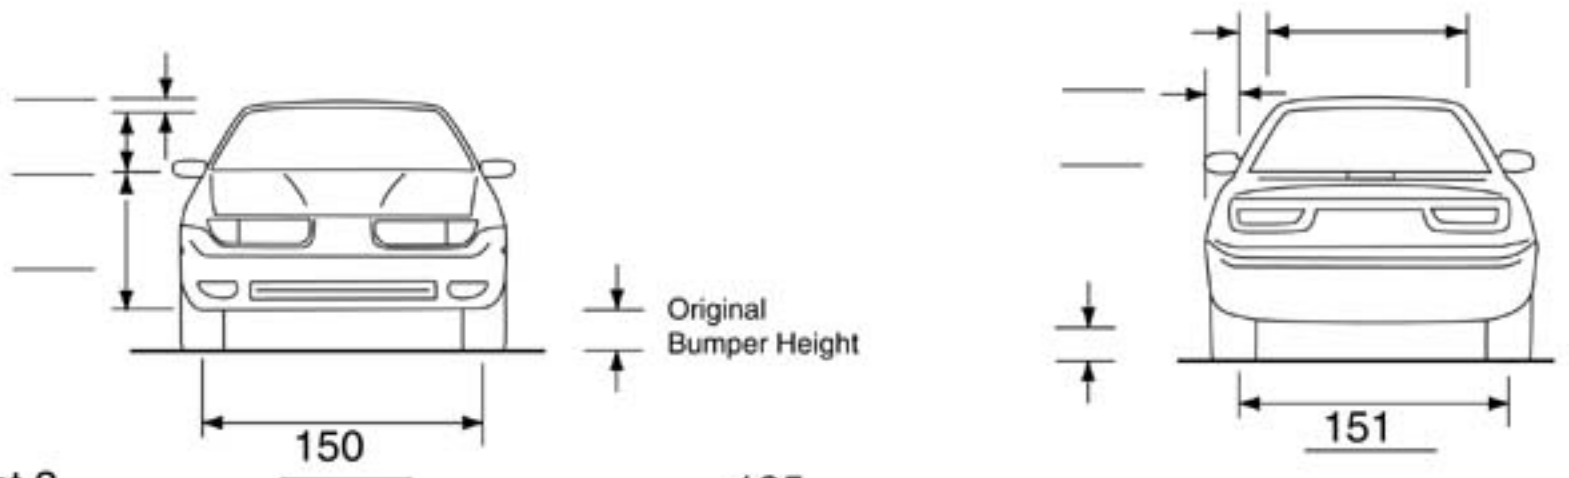
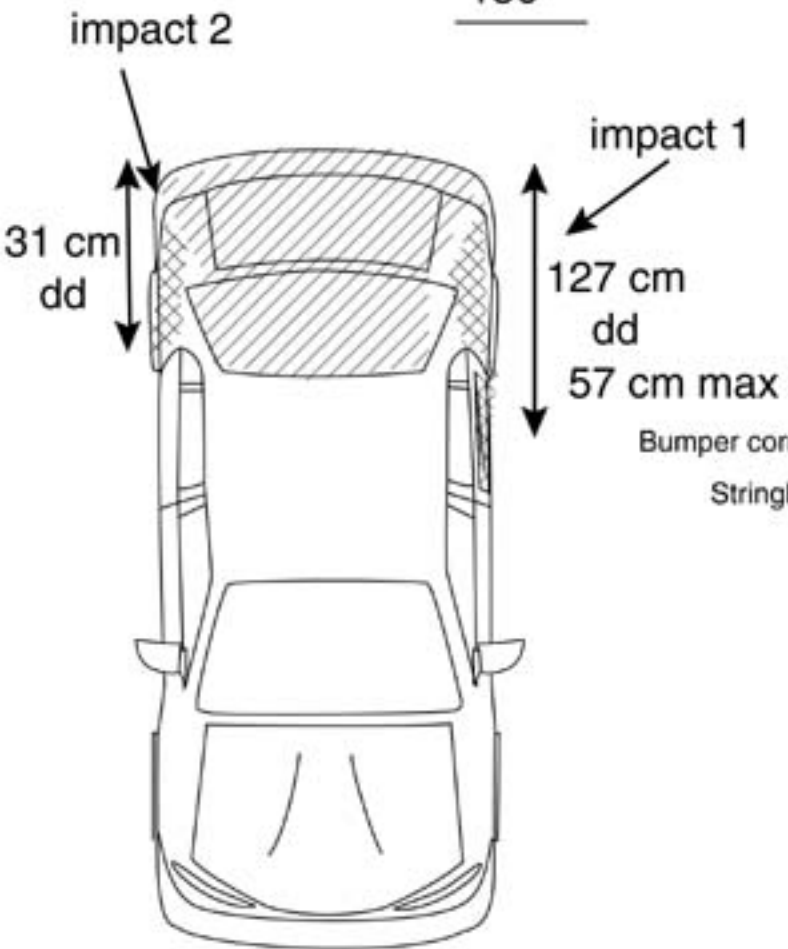
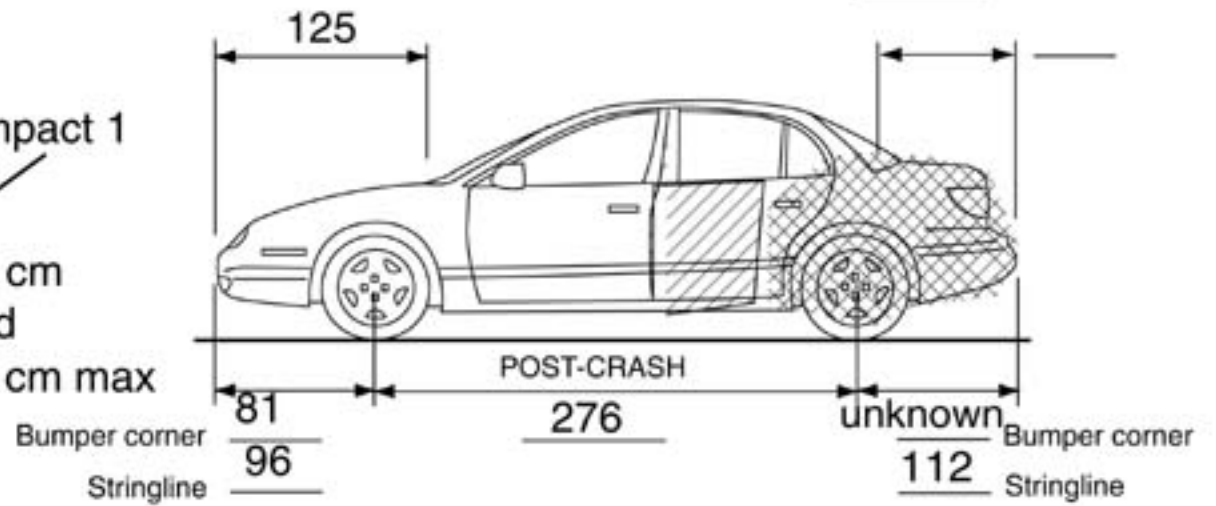
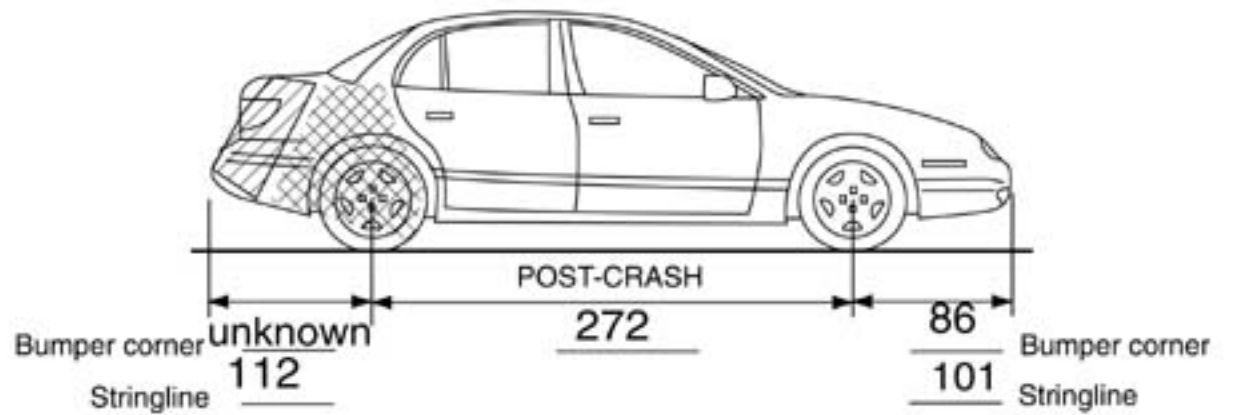
MEASUREMENTS IN CENTIMETERS

[4](#) The direct damage to case vehicle (A) began at the left-front bumper corner and extended 148 cm across the entire front of the vehicle. Both impacts were to the front of case vehicle (A), but the first impact probably caused the majority of the frontal damage. The maximum crush was 29 cm to the center portion of the front bumper.

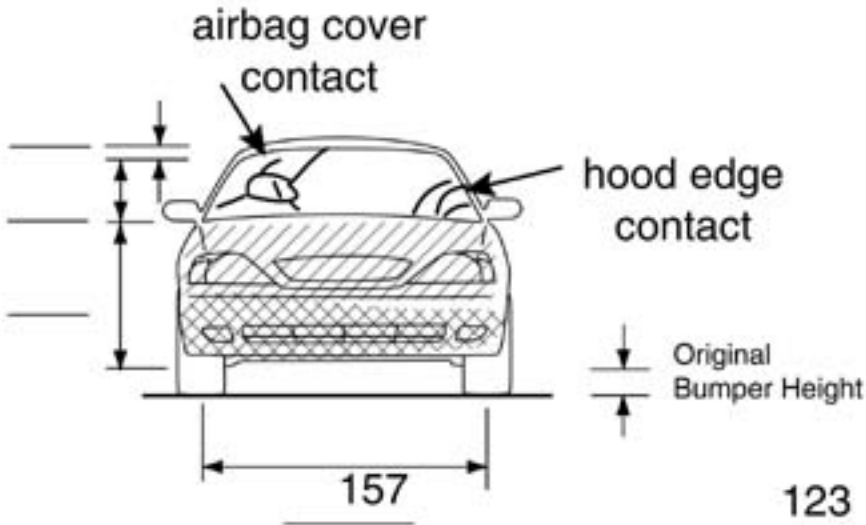
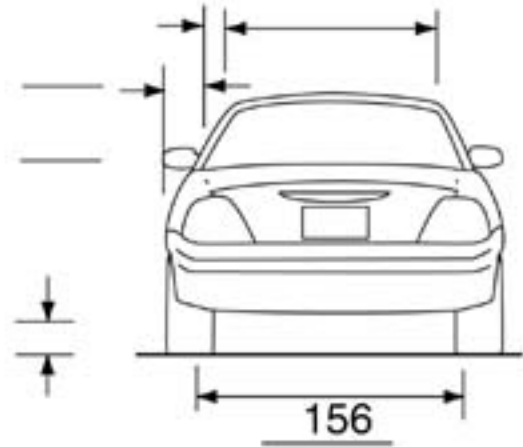
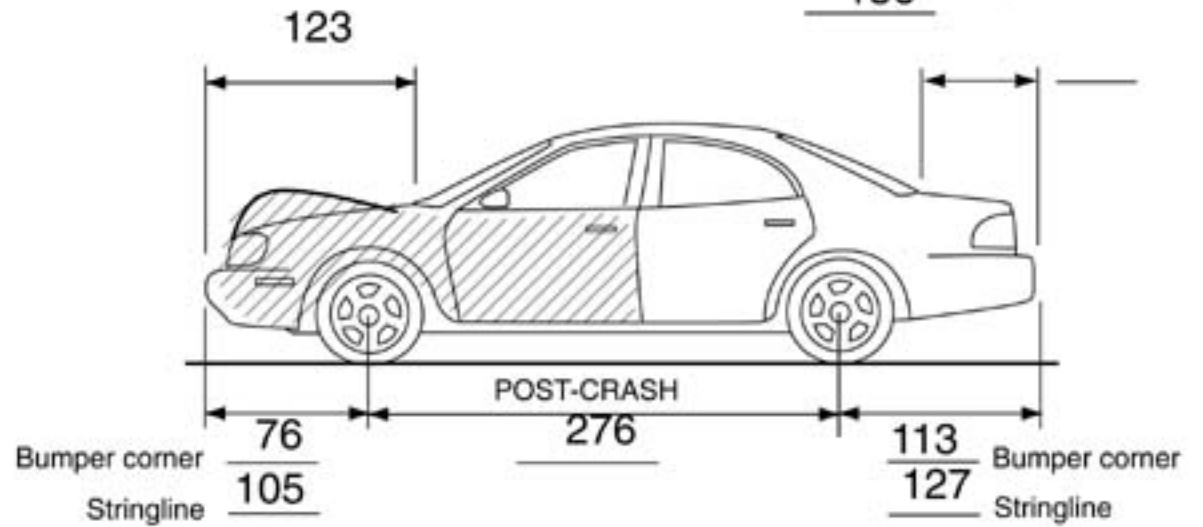
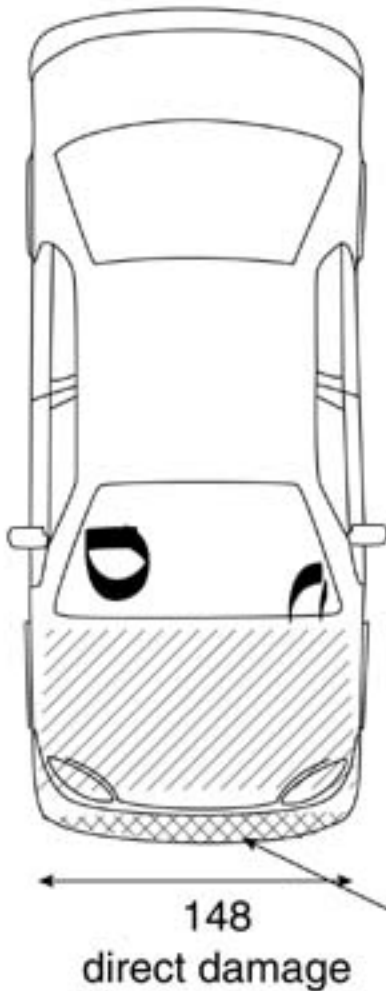
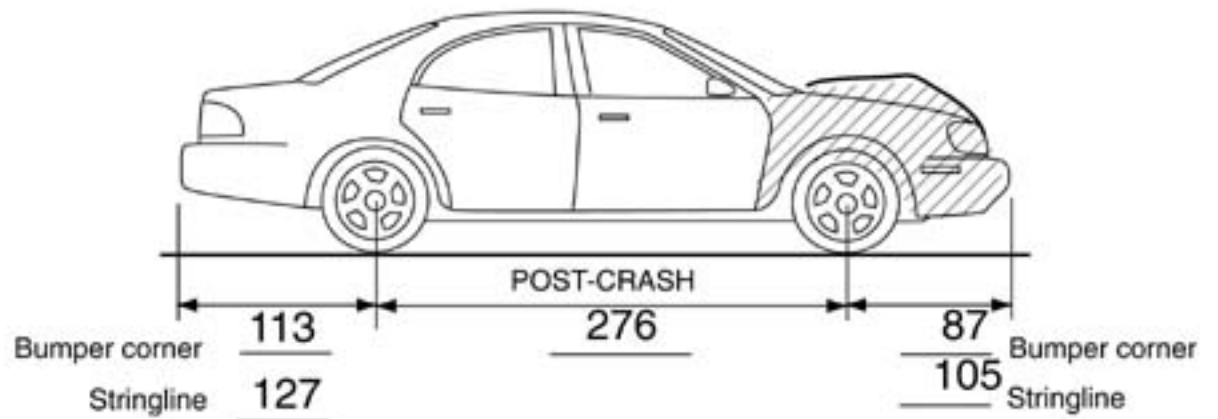
MEASUREMENTS IN CENTIMETERS

max crush is  
29 cm (17 cm from C2)

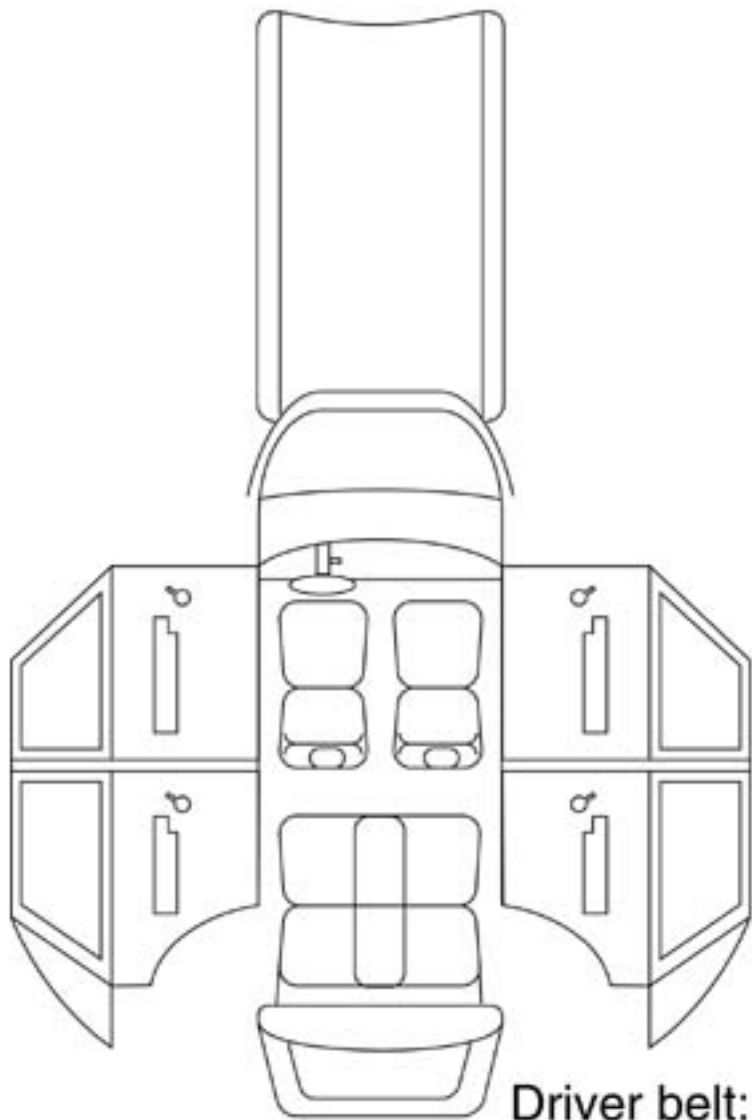
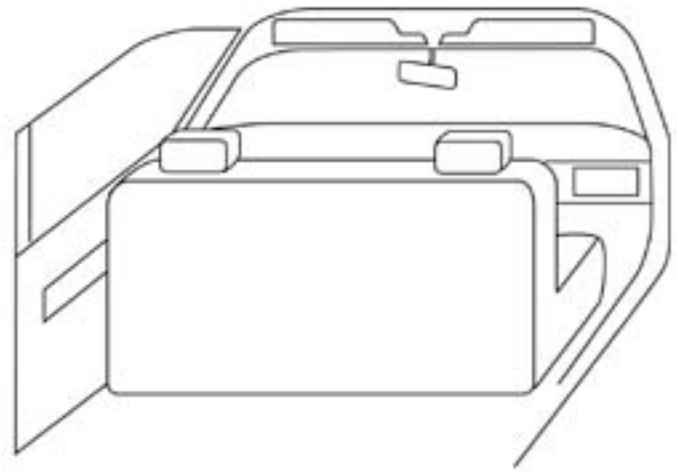
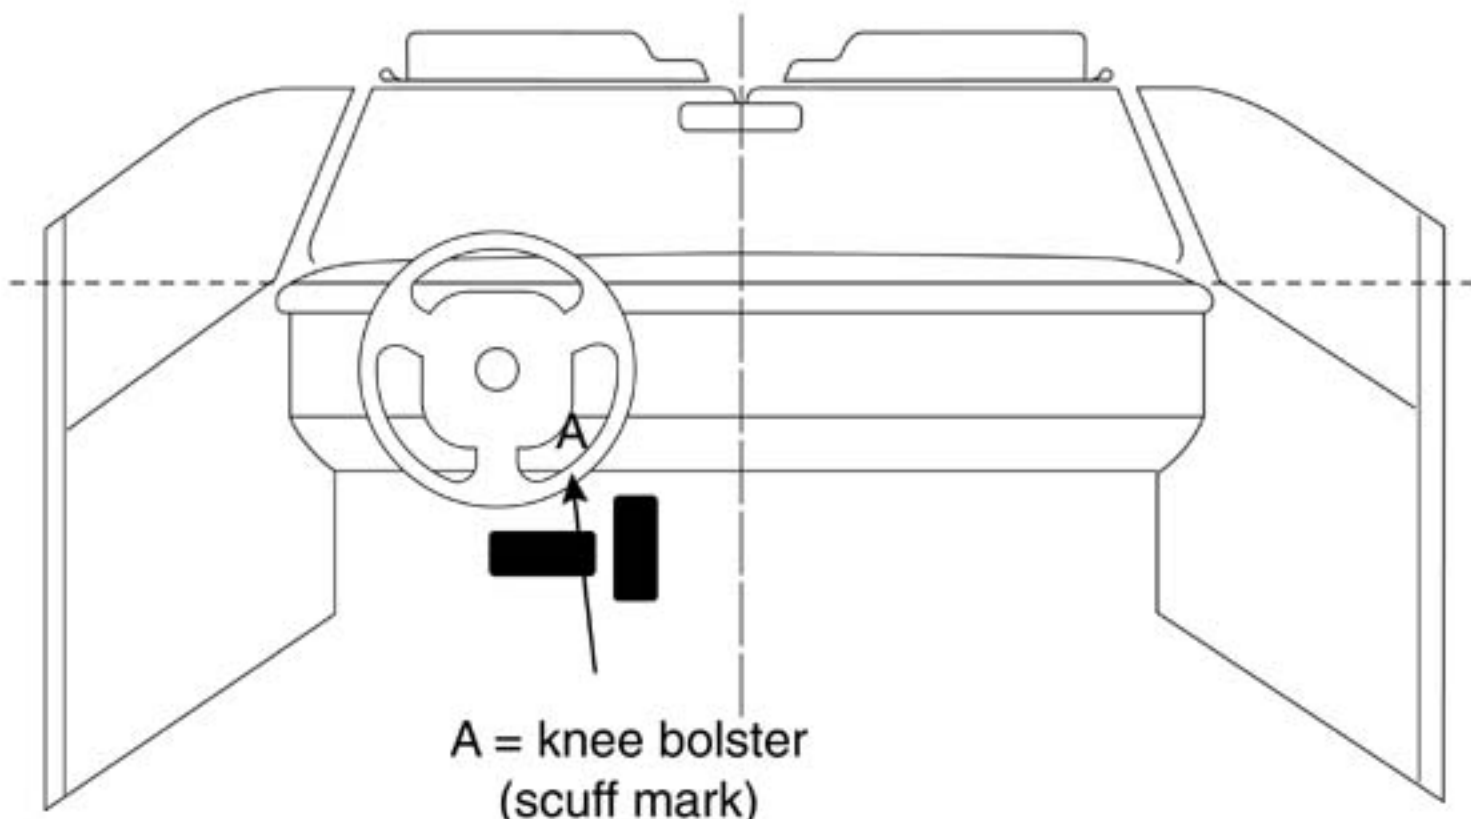
Contact	Interior Component Contacted	Occupant No. if Known	Body Region if Known	Supporting Physical Evidence	Confidence Level of Contact Point
A	Knee bolster	1	Knee	Scuff mark	1
B					
C					
D					
E					
F					
G					
H					
I					
J					
K					
L

Driver belt: No visible evidence of use on  
D-ring or belt webbing

adjusted to mid-to-upper position on B-pillar

A = knee bolster  
(scuff mark)
